WOMBAT FOREST ESTATE

“A rural subdivision case study”

By
John S. Duff
Conservation Officer

January 1980
SOIL CONSERVATION AUTHORITY
378 Cotham Road, Kew, Victoria 3101

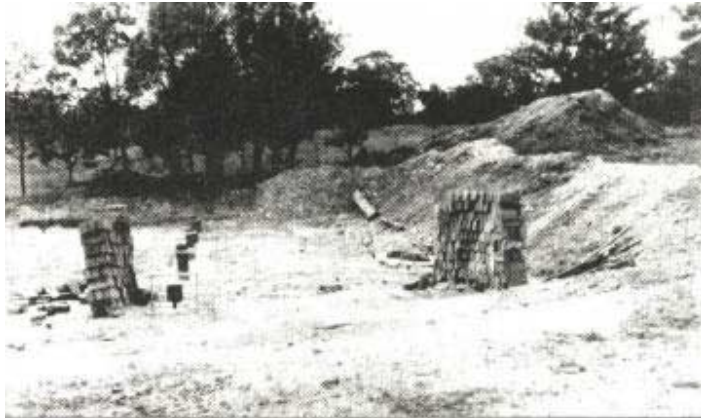
Plate 1 – Earthworks associated with house construction

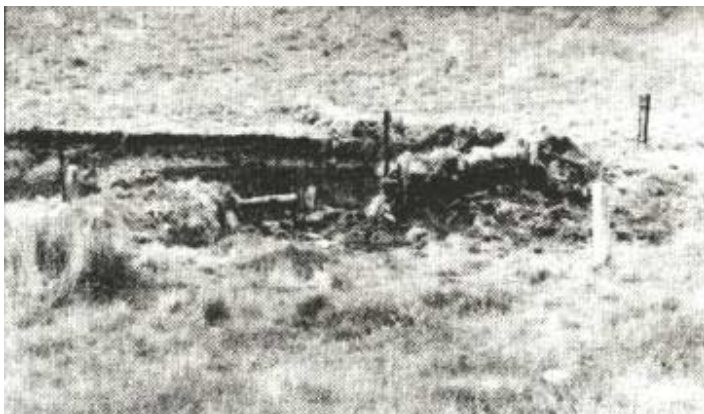
Twenty-four percent of the blocks have small earthen dams of 200 – 800 m³ capacity. One-third of these have either been poorly constructed or have required excavation above full supply level, both of which can lead to soil erosion.

Plate 2 – This hobby farmer's attempt at dam building may lead to erosion

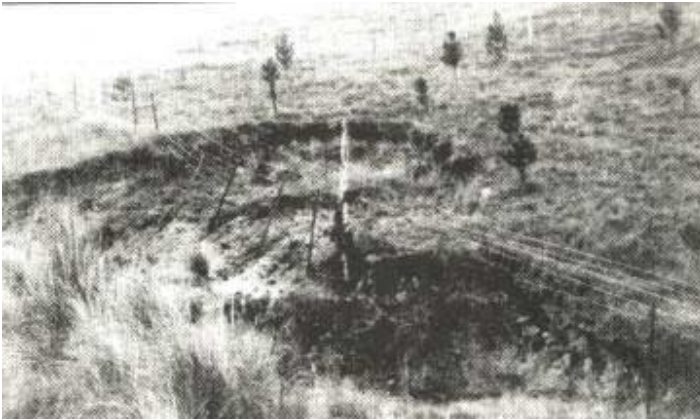
A small landslip (10 m long, 2 m high) occurred on Block 127 (Plate 3). In the same locality, dam seepage on Block 80 has initiated slumping of the road batter.

Plate 3 – Landslip – Block 127

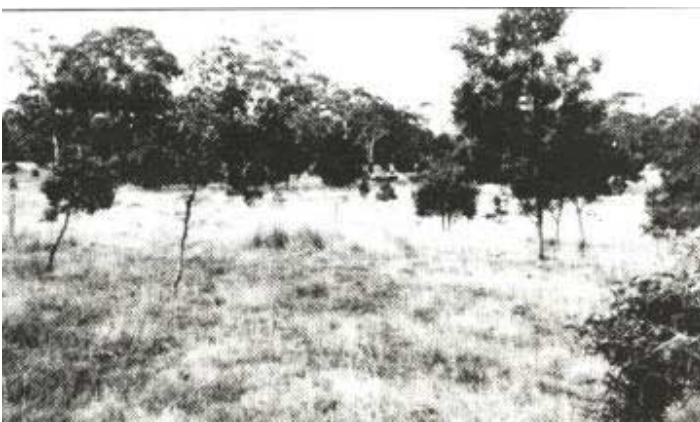
Plate 4 – Regeneration of native trees after fencing stock out of the area

Keeping stock out has encouraged regrowth of timber (Plate 4), allowed trees to be planted without expensive guards, prevented damage to existing trees and fostered the growth of other vegetation. The extra trees will directly benefit soil conservation, as in the future they will transpire large quantities of water thereby reducing runoff and infiltration, subsequently avoiding erosion and soil salting.

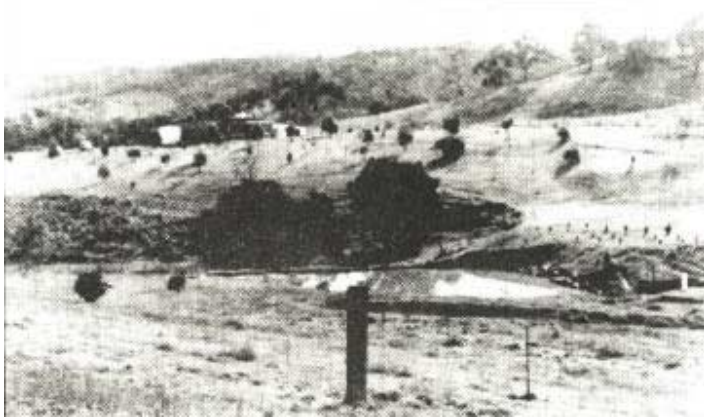
Plate 5 – Tree planting is a common practice

From the conservation point of view, another pleasing result of the survey is the number of lots on which people are planting trees (Plate 5). The number and different varieties of trees being planted is also pleasing. When the number of blocks already timbered, and the number being allowed to regenerate, is added to those being planted with trees, it is evident that at least 80% of the sub-division will probably present a “parkland setting” in 10 years time. The amount of tree planting on surrounding farm land is negligible.

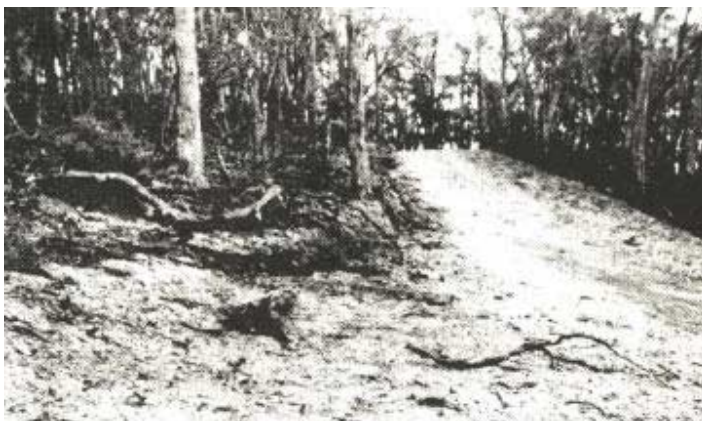
Many small lot owners who contact the Soil Conservation Authority for advice require enough water for 0.2 ha of garden/lawn, five people and two horses. The ideal dam size for these requirements in this area is approximately 940 m³, based on 4% runoff and a storage period of 18 months. The catchment area needed is approximately 2.1 ha. On this sub-division, 47 lots must accept a lower standard of water use due to insufficient catchment. Blocks 73-80 and 130-132, because of the rocky soil and steep slopes have no suitable sites at all (Plate 6).

Plate 6 – Steep slopes and rocky soils result in few good dam sites

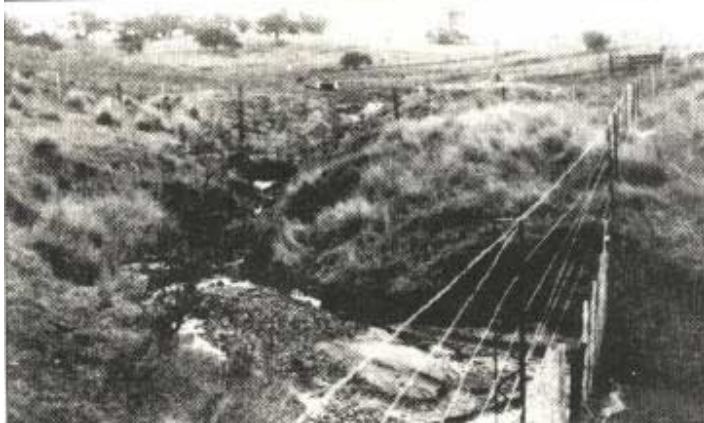
Several lot owners appear to have been misguided with dam construction, many of which area of poor construction. Plates 7, 8, 9 and 10 illustrate the point. So far, only one of these dams (Plate 7) has actually failed and caused sedimentation. However, others could fail.

Plate 7 – Sediment in the gully floor from a failed dam. This will reduce the capacity of the dam further down the drainage line

It appears that most lot owners would be far better off if a reticulated water supply could be made available to this sub-division. The high fire risk would also be eased by a reticulated water supply.

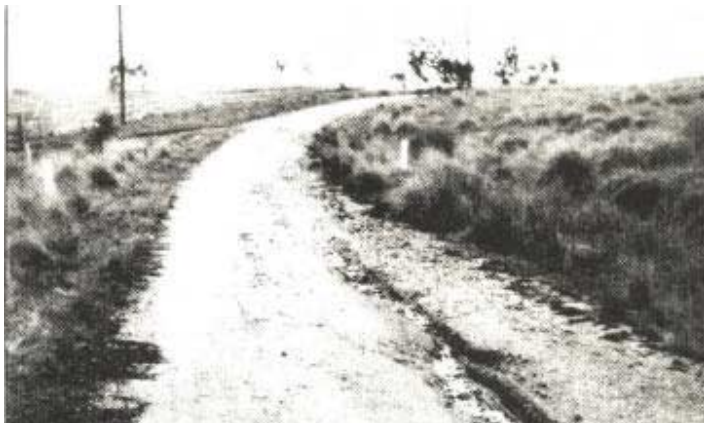
Road surface erosion has occurred on Shuter Avenue (plate 8) and the northern end of Hastings Road. Road surface erosion is often masked due to maintenance and replacement of gravel although it is still a significant contributor of sediment to streams and eventually, in this case, to Pykes Creek Reservoir. Track erosion occurred on 8% of tracks and is a similar problem to road surface erosion.

Plate 8 – Road surface erosion – Shuter Avenue

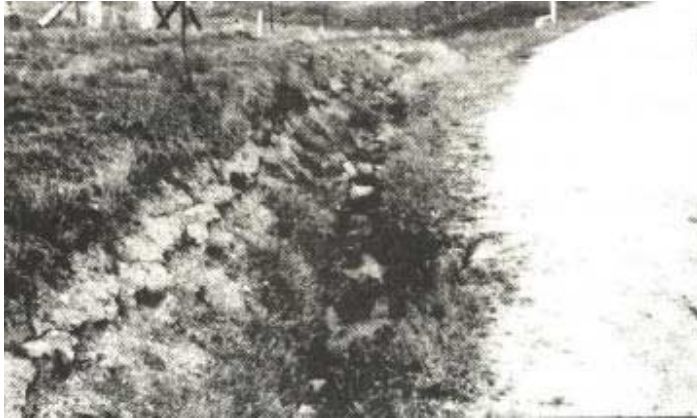
Erosion in the table drains is present and will become worse as more blocks are developed. (plate 9). Hard surfacing, associated with tracks, buildings, clearing and overgrazing, increases runoff to table drains. In this sub-division, the effects of these factors could be tripled if all blocks are developed. By using half-round “armco” farming on one side of Shuter Avenue, most of the table drain erosion could have been avoided on the sub-division.

Plate 9 – Table drain erosion – Shuter Avenue

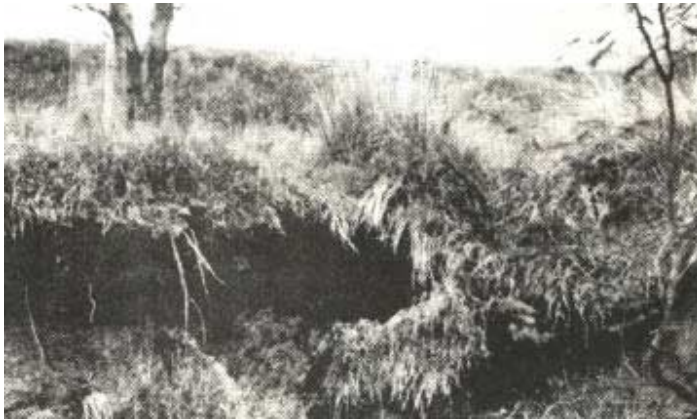
Plate 10 – The top of a 5 m deep bully head on Lot 127 is below the well grassed dam bank

A major planning criticism of this sub-division is associated with the problem of the two gully heads on two blocks (Plate 10). These areas could have been declared reserve areas, as was done for the Reserve west of Shuter Avenue, and erosion control works carried out. The owners of both blocks appear to be reluctant or unable to cope with these problems, which will eventually threaten Shuter Avenue and the blocks above Block 83 if left untreated. Both these gully heads, as well as the head in the Reserve west of Shuter Avenue, showed signs of re-activation.

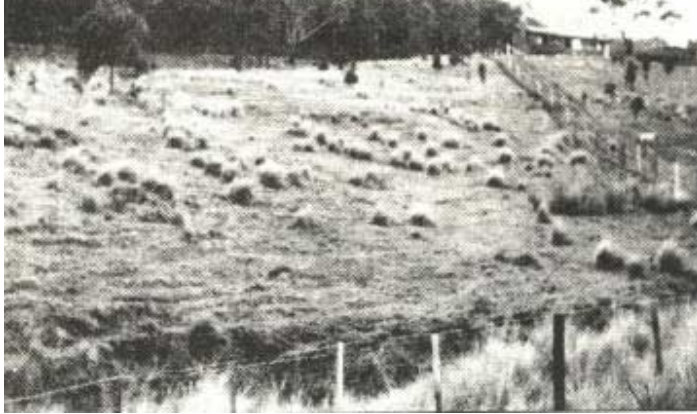
Overgrazing and heavy grazing occurred mainly in the first year of the study (1975), following a dry autumn and winter. Some of the surrounding farm land was also over-grazed in that year but not to the same extent as that which occurred on the estate.

The overgrazing/heavy grazing possibly indicates the lack of flexibility of grazing management, the lack of understanding of the all-year carrying capacity of the land the absentee management of the block owners. None of the lots was overgrazed or heavily grazed on more than one survey date, indicating that perhaps the owners are learning from experience.

Plate 11 – This block is recovering from heavy grazing during the previous year. Note that the unpalatable tussock grass (*Poa australis*) remains
