## 7.2 Avoca land system

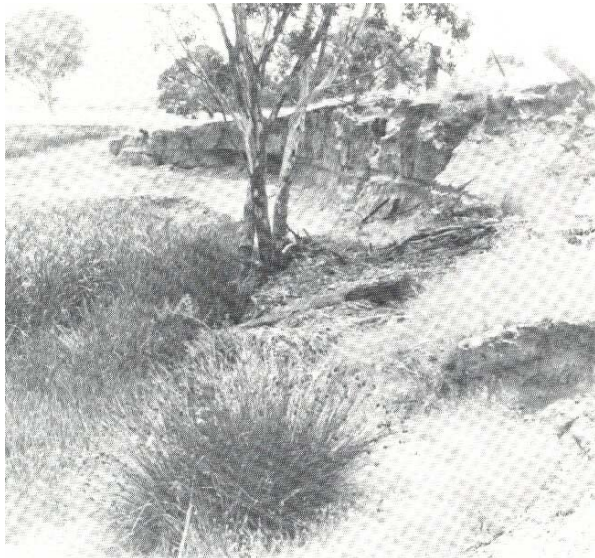
*Streambank erosion (above) is an active process during flood periods.*

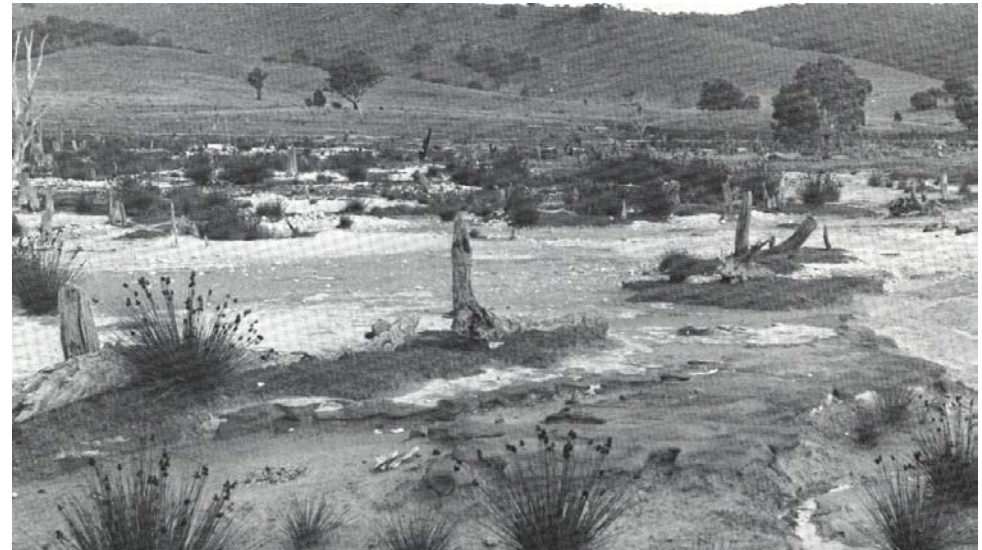
*Shallow saline water tables caused by excessive clearing in the catchment severely reduce the productivity of the fertile alluvial soils.*

The land is comparatively stable. However, cultivation, trampling by livestock and other activities have compacted the original moderately structured surfaces, resulting in increased run-off and reduced plant vigour. Minor saline seeps occur in narrow alluvial terraces flanked by cleared parts of the Pyrenees Range.
