7.11 Glenlogie land system

GLENLOGIE LAND SYSTEM Area 17 sq. km

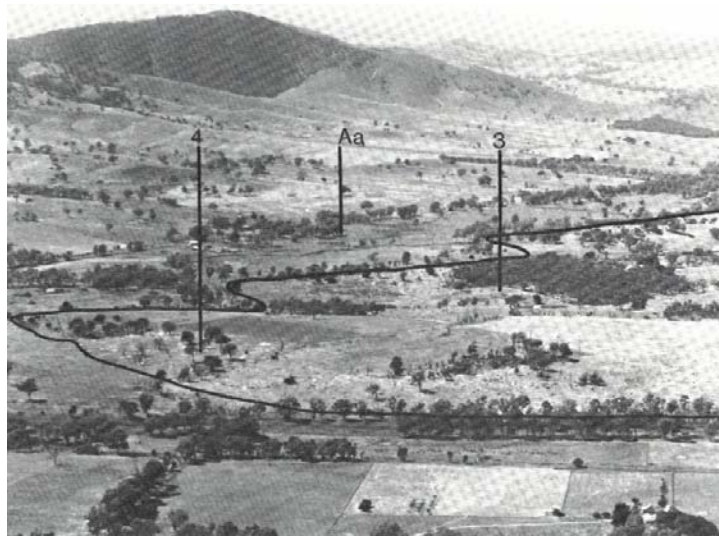
The low agricultural potential of this land system is directly related to the extremely low nutrient status of the old river gravel deposits.

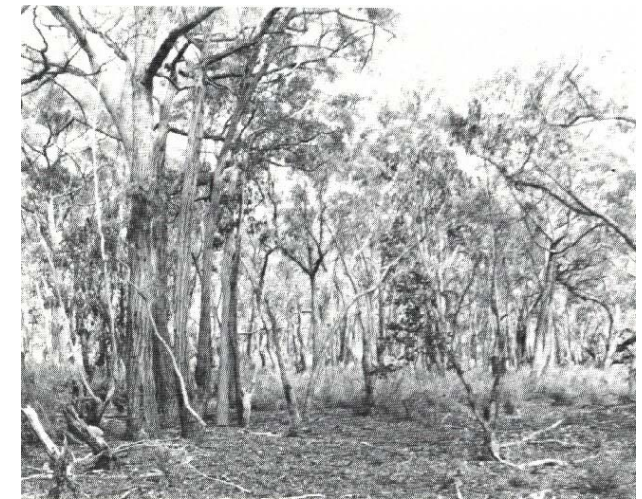
The heathy woodland has a characteristic straggly appearance.

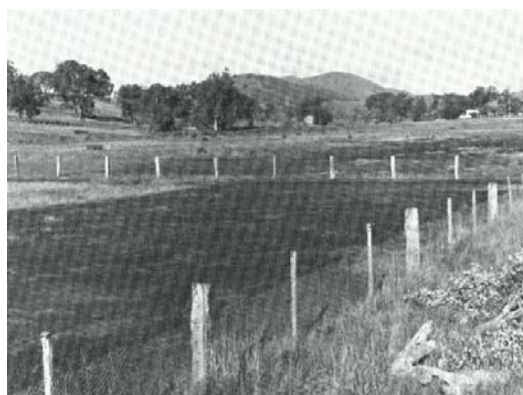
A rising saline water table, has caused soil salting, and subsequent low pasture production.

Raised water table	2	Increased evaporation	Soil salting	Low	Increased salinity of surface waters
	4	Increased evaporation	Soil salting	Moderate	Increased salinity of surface waters

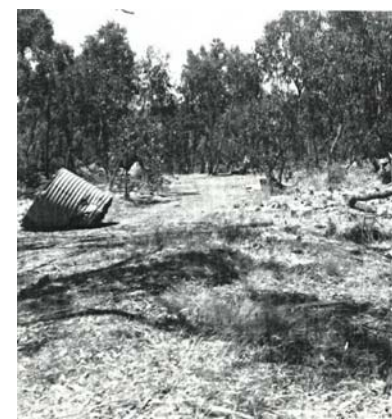
The rather straggly appearance of these gravelly areas deteriorates further when they are used as rubbish dumps.
