7.22 Sugarloaf land system

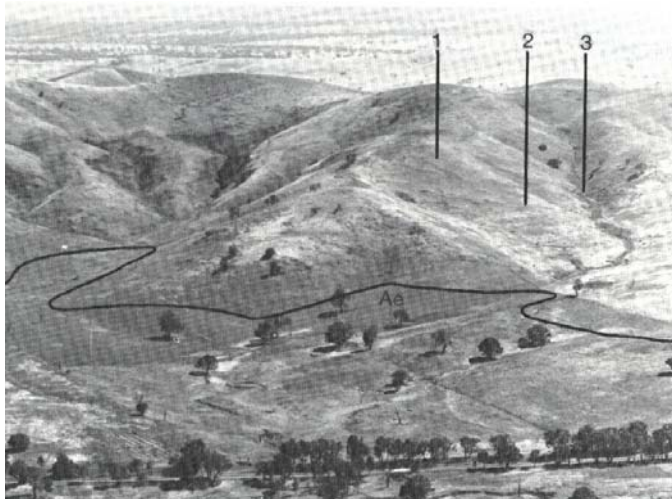
Sugarloaf land system includes some of the steepest cleared land in the catchment.

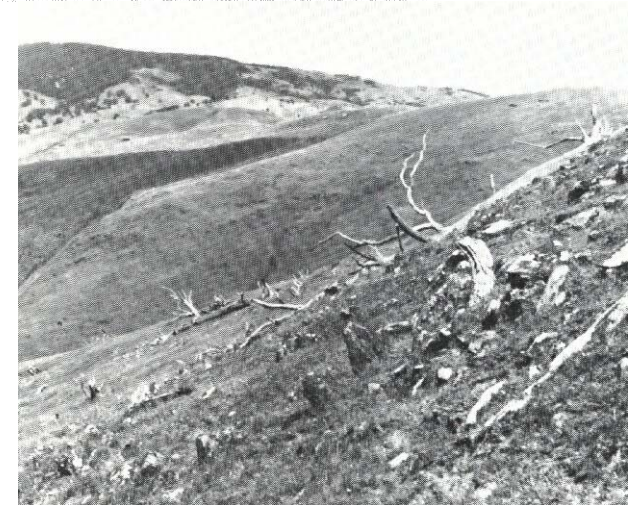
Annual grasses have low productivity and do not adequately protect the shallow soils against water erosion.

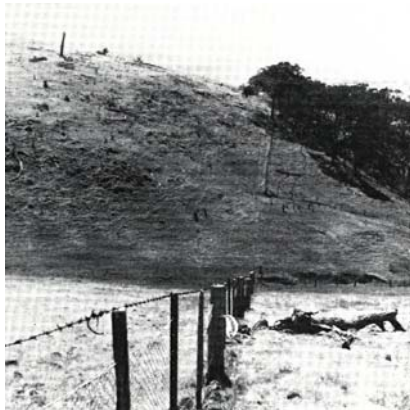
The steep cleared slopes are highly susceptible to sheet erosion.

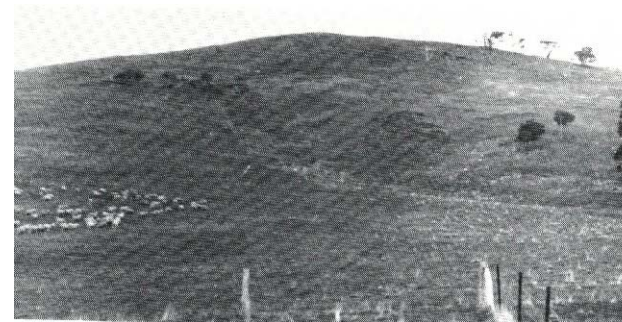
Some areas have become unstable after clearing, resulting in small landslips.
