7.3 Bald Hill land system

BALD HILL LAND SYSTEM Area 60 sq. km

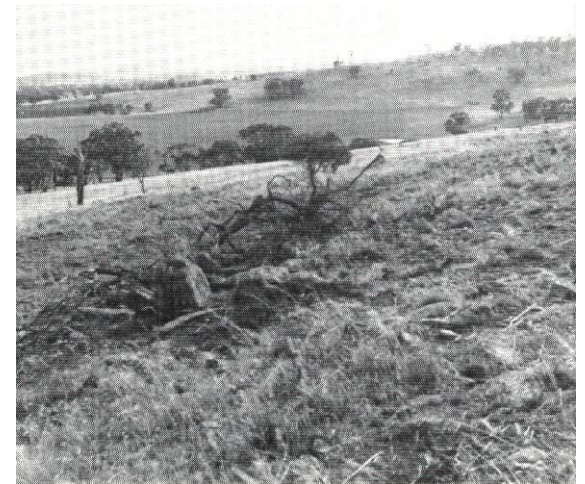
A permanent cover of native grasses is required on the upper slopes to minimise the sheet erosion hazard.

Productivity is low on the cleared metamorphic hills in the drier northern areas of the catchment.

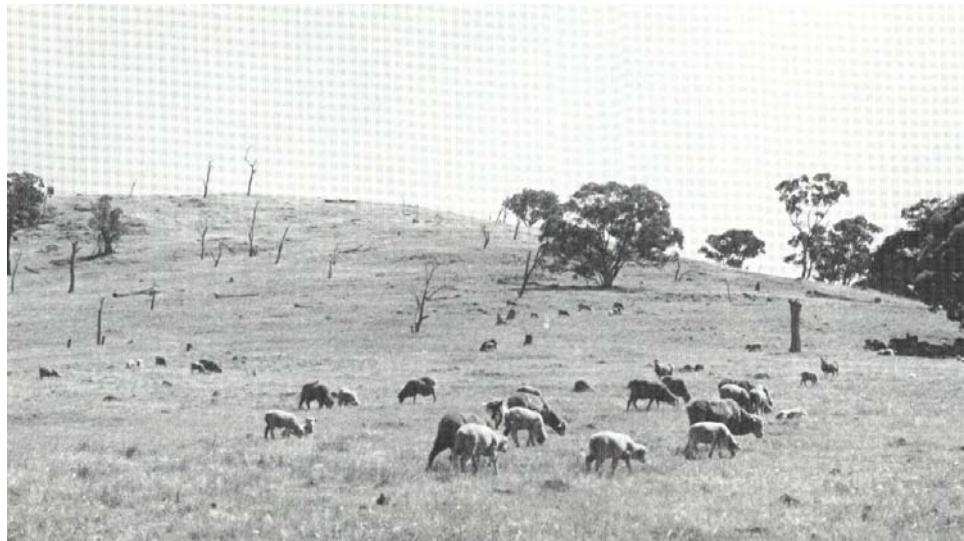
Sloping land with shallow stony soils and low nutrient status is extremely susceptible to sheet erosion when cultivated.
