## 7.6 Buckrabanyule land system

**BUCKRABANYULE LAND SYSTEM Area 113 sq. km**

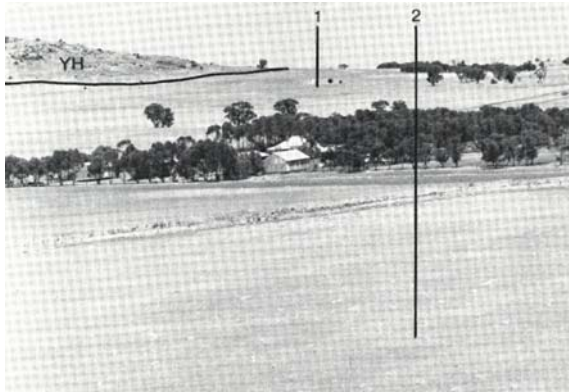
*This area, used predominantly for cropping, slopes gently away from steep granitic hills.*

This area, used predominantly for cropping, slopes gently away from steep granitic hills. Gully erosion (right) is common on the upper slopes.

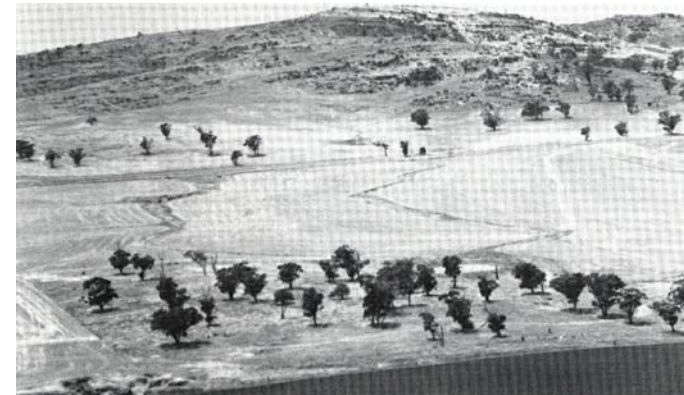
*Gully erosion (right) is common on the upper slopes.*

The upper slopes are particularly prone to gully and sheet erosion. Gullies are prominent in the drainage lines, aggravated by run-off from the adjacent rocky hills, which have been excessively cleared and grazed. Gully dimensions are increasing steadily, promoted by the high slaking tendency of the soils.

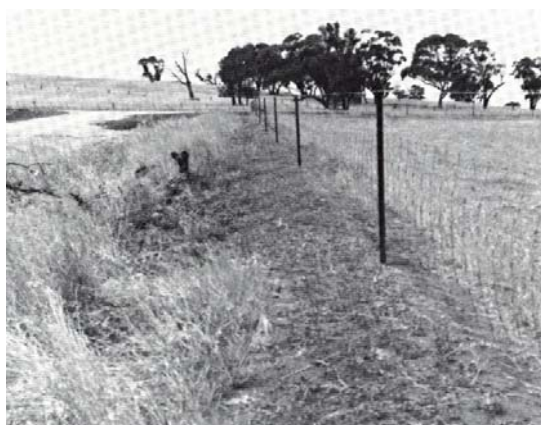
*Increased run-off from adjacent hills does cause severe gully erosion on the upper slopes in soils that have a high slaking tendency.*

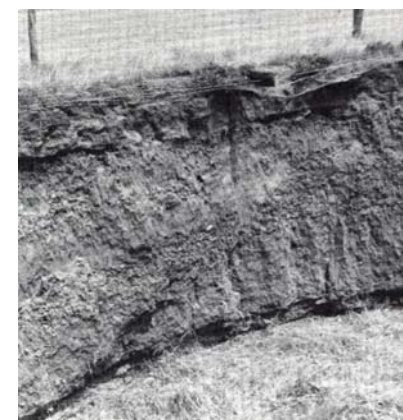
*The ridge of sandy material along the fence-line indicates the extent of wind erosion over the years.*
